ShopTalk

All Options Are Not Equal For Good Aluminum Repair

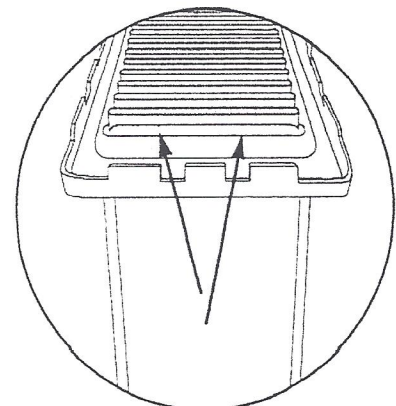
After the tank and gasket are removed, pinholes often are discovered in the tube-to-header joint(s) (see arrows) on the water side.

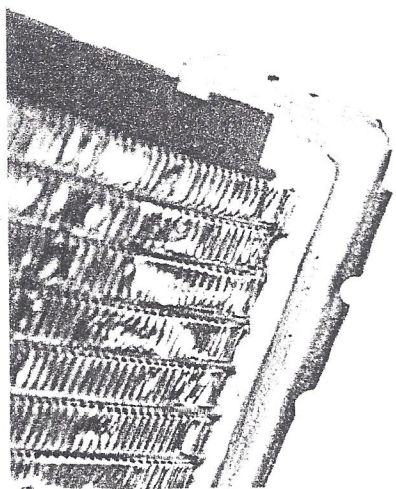
Figure 3

In this view we see the Alumabond that was applied around the tubes on the air side, replacing the header epoxy that was carved out.

- "Paddle in" the Alumabond epoxy on the air side to replace the epoxy which was removed (see Figure 3). Work the epoxy into pinholes that are visible, building it up around the base of the tubes to a depth of about 1/4", then feather out the edges. (Note: If you are repairing a hole in a tube, it's a good practice to enlarge the hole slightly, using an ice pick, so that epoxy can be forced into the hole more effectively. Doing this, in combination with a good bond on the outside of the tube, provides the strongest epoxy seal. Some shops use a vacuum to pull epoxy into a hole, providing that the radiator can be repaired with its tanks in place).

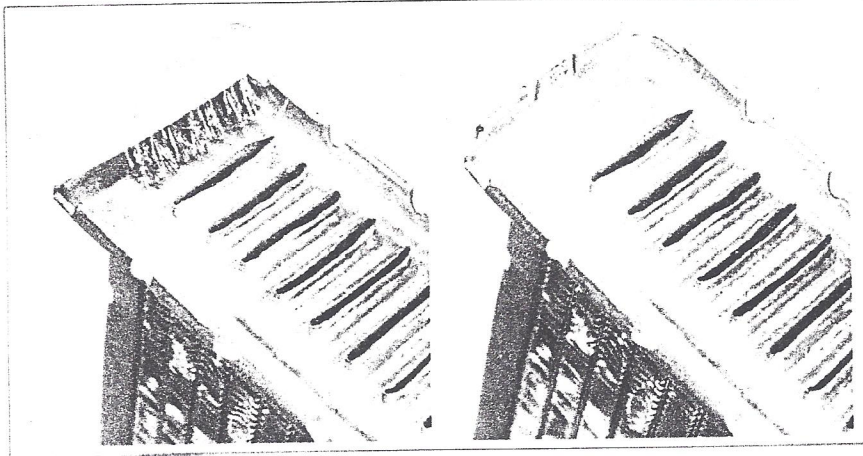
Figure 2

A small stainless steel brush is handy for cleaning aluminum prior to making a repair. It is best not to use a brush that is excessively abrasive so as to cause gouges in the tank trough. Above right, we see that the area to be repaired (on the water side) has been nicely cleaned by the brushing action.

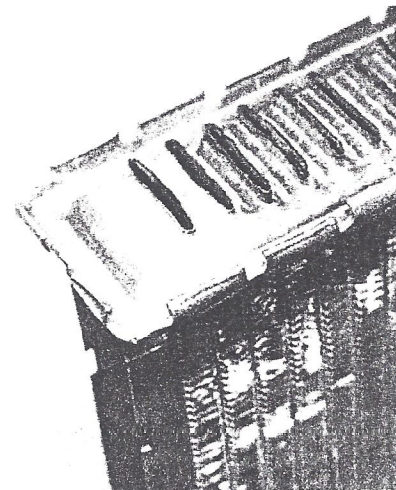
Figure 4

Here we see Alumabond applied around two of the tubes on the water side of the header to seal the source of the leak.

- Next, apply more Alumabond around the tubes on the water side of the header, without

disturbing the fresh epoxy on the air side (see Figure 4). Build up the Alumabond so that it is level with the tube ends, being careful not to plug them. Smooth the epoxy to a feathered edge, with movement away from the tubes. (Note: Do not allow any Alumabond to cure in the gasket trough. If some gets in there when you're applying it to the header, wipe it totally away with a clean dry rag on the tip of a screwdriver. For GM aluminum radiators that have those wide gaskets with a flange, avoid buildup of any epoxy on the header that may interfere with seating the gasket).
